HOLE-TYPE NOZZLES  
WITH RESTRICTED  
SPRAY ORIFICES

Workshop: EP  
02.1992  
0311 En

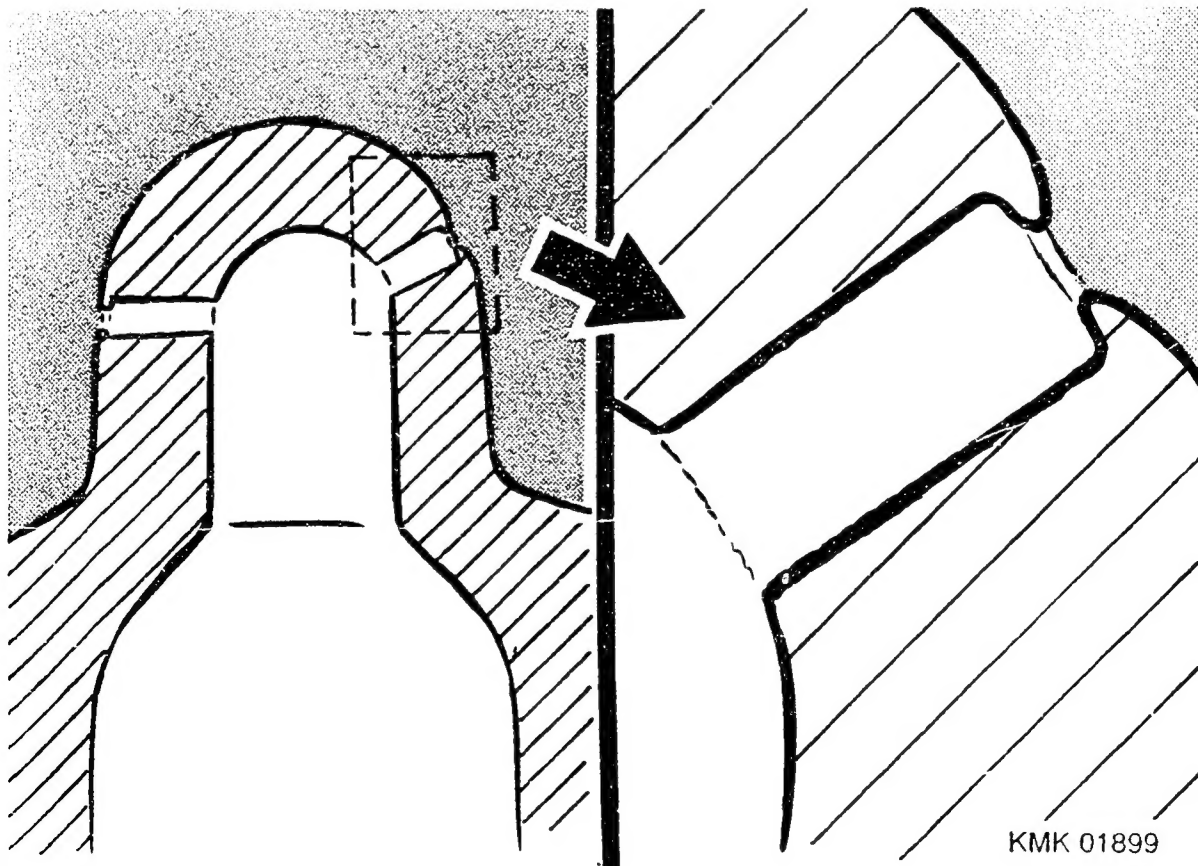
KMK 01899

Enlargement of restricted spray orifice.

The edges of the spray orifices are normally sharp (even on used nozzles). Nozzles with restricted spray orifices are always to be scrapped and replaced with new ones.

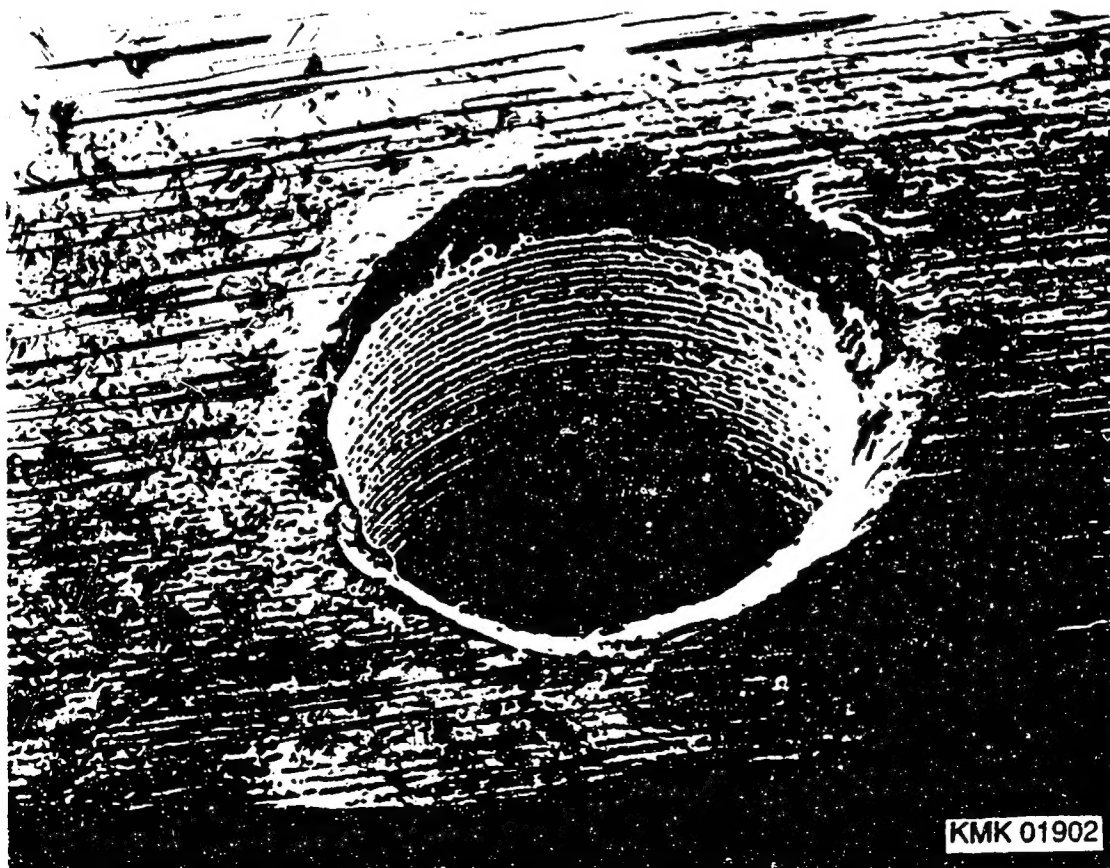
Restricted spray orifice edge.  
Reduction in flow approx. 5 %.

The spray orifice edge is no longer sharp, but rather clearly rounded.

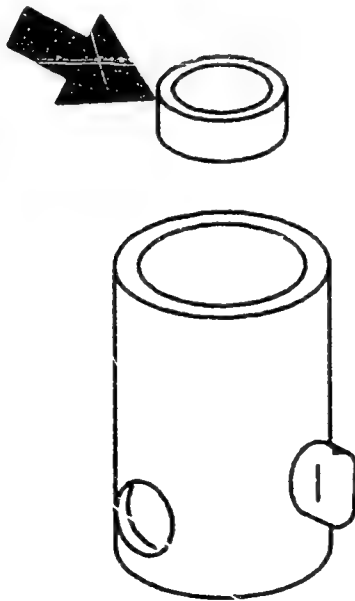
KMK02600

If it becomes necessary to replace roller tappet assembly 2 418 750 022 because of a broken pressure plate (see illustration), you must replace all 6 with part numbers 2 418 750 041. After doing so, we remind you to check plunger LPC and phasing.

Arrow = Pressure Plate

The exchange of the roller tappet assemblies is to be performed only in the event of breakage.  
Standard warranty terms apply.

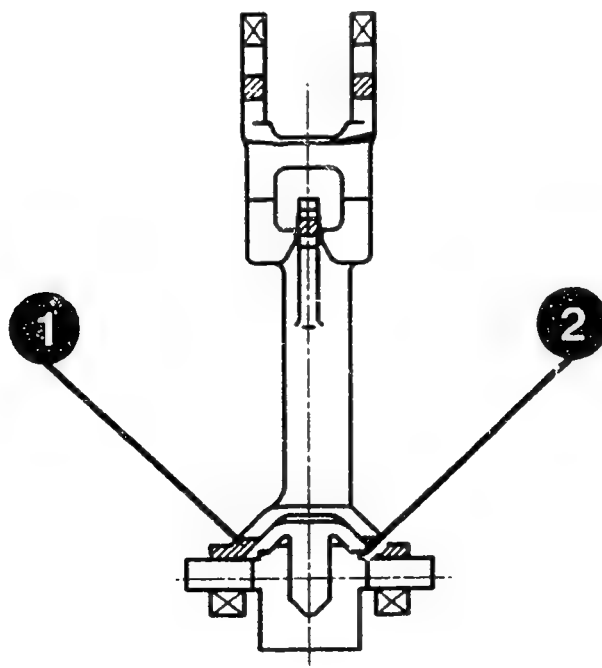
KMK02601

If, on replacing a fulcrum lever, it is established that this makes contact as shown with the sliding block, DO NOT ALTER THE FULCRUM LEVER IN ORDER TO CREATE A SPACE, but rather replace the sliding block with part no. 2 422 130 038.

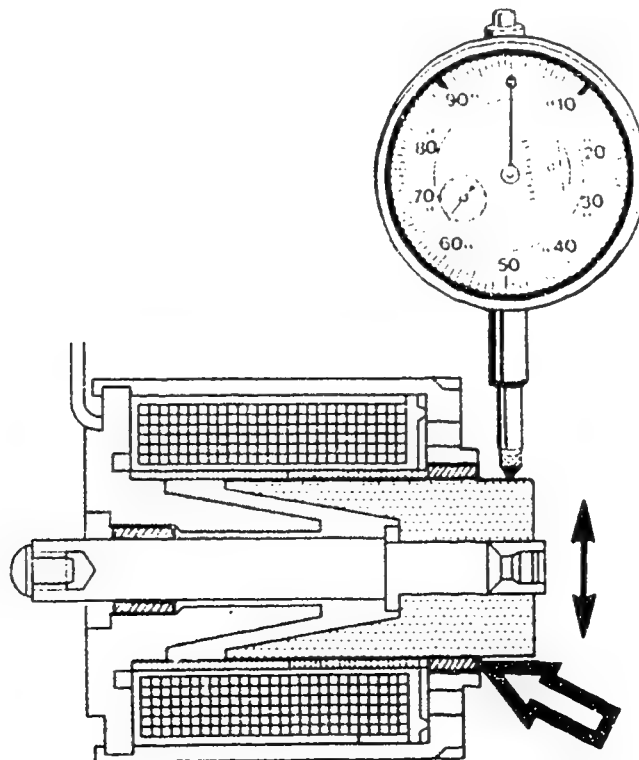
KMK 03078

The problem is usually caused by a stiff electromagnet armature in the adjusting magnet of the RE positioner due to one-sided wear of the large electromagnet-armature bushing (picture, arrow).

Such wear cannot be detected during normal testing of the IP assembly on an IP test bench. For this reason, should such complaints be received, the adjusting magnet is to be removed and the bearing wear measured.

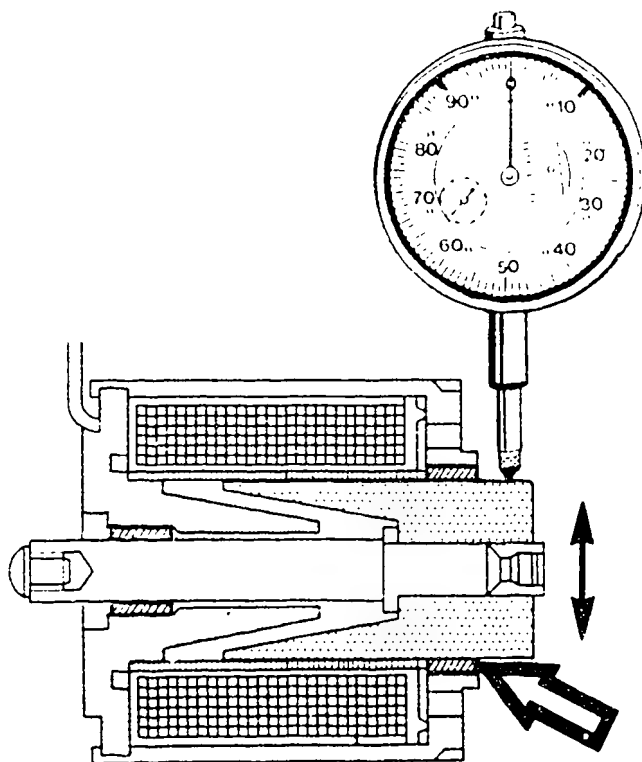
KMK 03078

The max. bearing clearance for the large bushing is 0.12 mm.

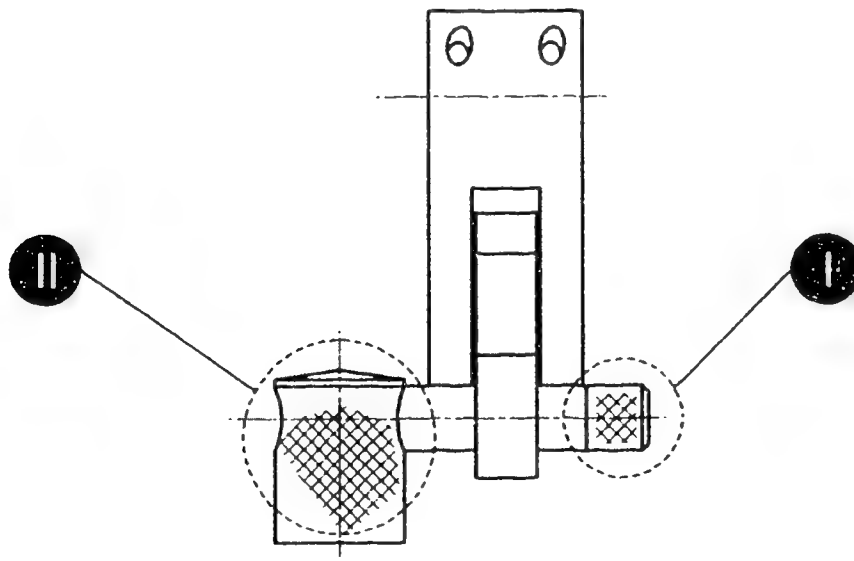
KMK01709

If the wear dimension is obtained or not reached, the entire assembly is to be replaced.

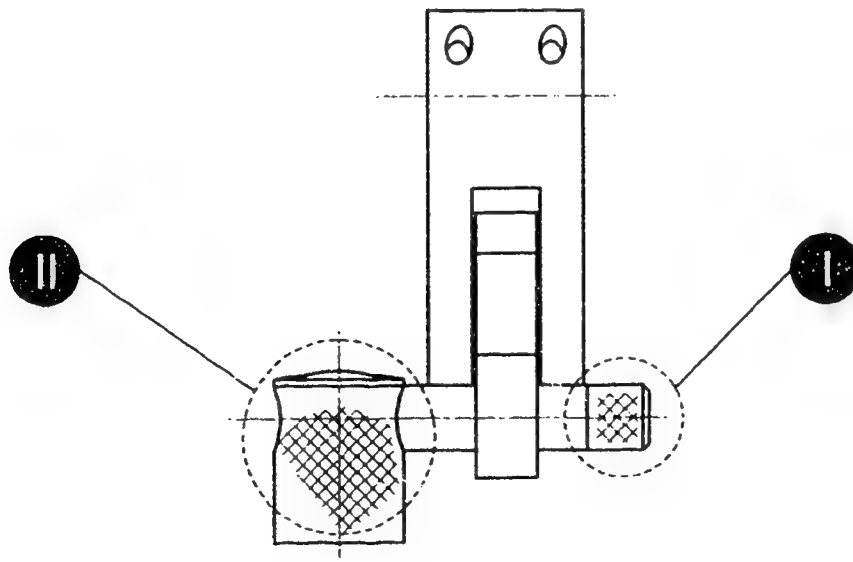
KMK01709

If one of the two situations outlined above is encountered, the assembly is to be renewed. The variable-fulcrum lever is likewise to be assessed.

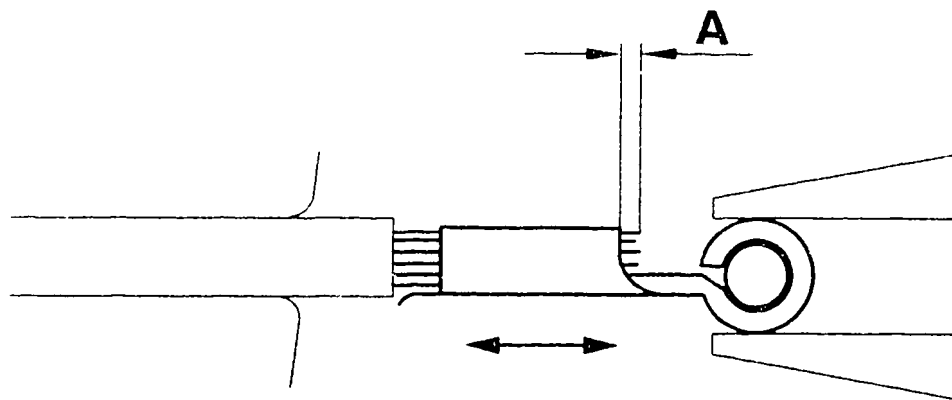
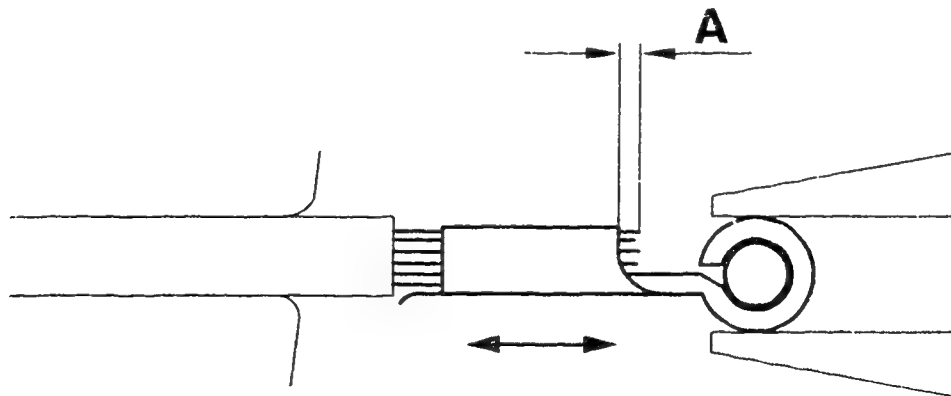
KMK04056

- \* There should be no change in the length of the protruding end of the stranded wire (dimension A, see picture) on moving the lead.
- \* The crimp is defective if there is even minimal relative movement between end of stranded wire and crimp.

Note: All positioners from the start of series production up to date of manufacture 266 and no. 158 may be affected by faulty crimps. Proper ex-works crimping is ensured with newer positioners.

If a crimp is loose the appropriate component (control-rod-travel or engine-speed sensor) is to be replaced. Pay attention to the detailed specifications in the repair and testing instructions VDT-W-400/019.

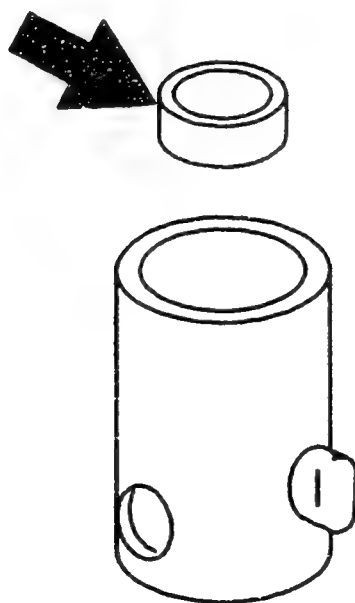
KMK02600

If it becomes necessary to replace roller tappet assembly 2 418 750 022 because of a broken pressure plate (see illustration), you must replace all 6 with part number 2 418 750 041. After doing so, we remind you to check plunger LPC and phasing.

The exchange of the roller tappet assemblies is to be performed only in the event of breakage. Standard warranty terms apply.
